Five-Year Review Report

Second Five-Year Review Report  
For  
Rasmussen Dump Site  
Livingston County  
Hamburg, Michigan

Prepared By:  
U.S. EPA Region 5  
Superfund Division  
Remedial Response Branch #2  
Remedial Response Section #5  
77 West Jackson Boulevard  
Chicago, Illinois 60604

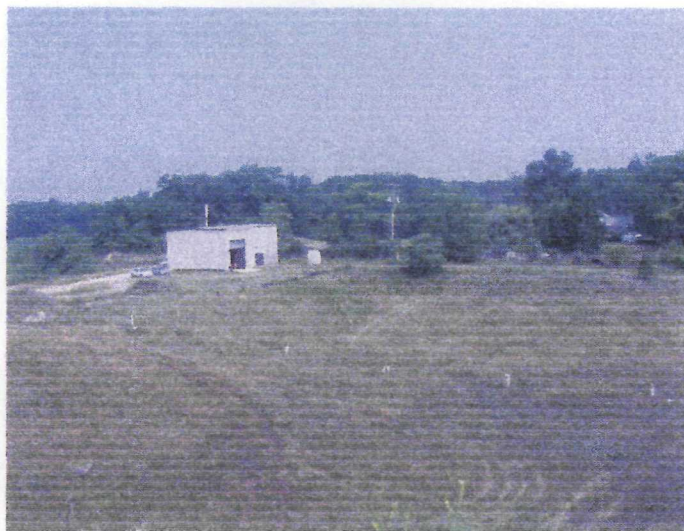
The groundwater is being treated with an Ozone/Oxygen Sparging System. The ozone/oxygen sparging system consists of an air compressor, oxygen concentrator, ozone generator (ozone generated by super high voltage), a distribution panel and more distribution valves in front of the treatment plant. The system is in good condition. The sampling ports are properly marked and functional and the equipment was properly identified. The electrical enclosures and panels appeared to be in good condition. The treatment building also appeared to be in good condition.

Photo 1: Treatment Plant Building

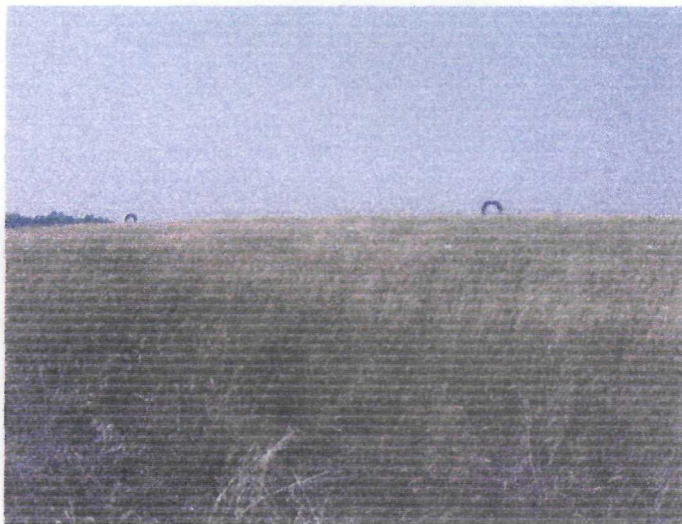
There was no evidence of settlement, cracking, erosion, holes, bulges, water damage or slope instability in the landfill cover. The landfill cover is comprised of grass.

Photo 2: Top of Landfill
